Sample name: TABLE LAMAX V2

TEST REPORT

Vertical static load test EN 1730:2012, clause 6.3

Horizontal fatigue test EN 1730:2012, clause 6.4.2

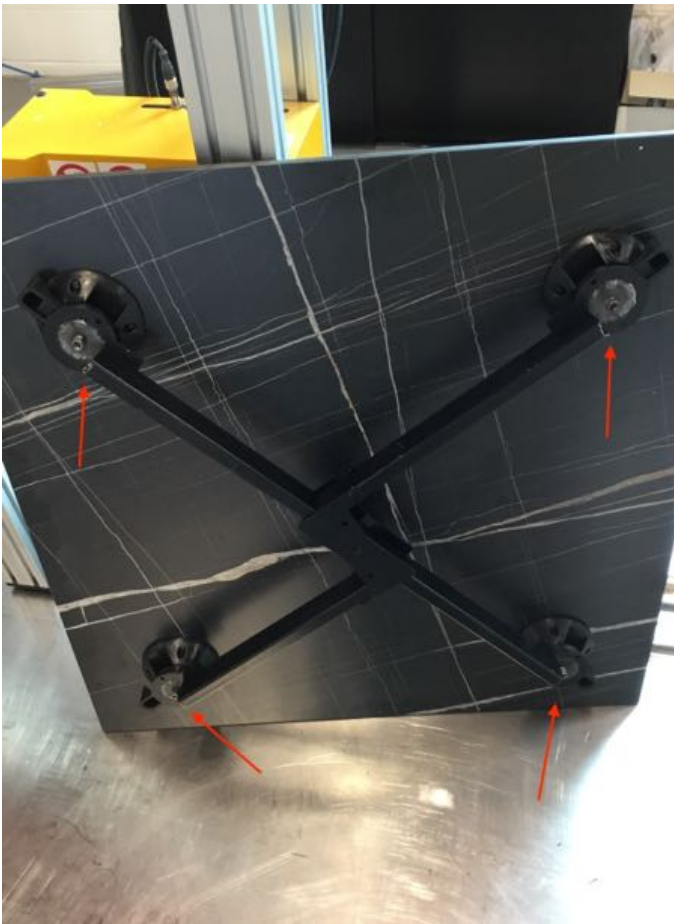
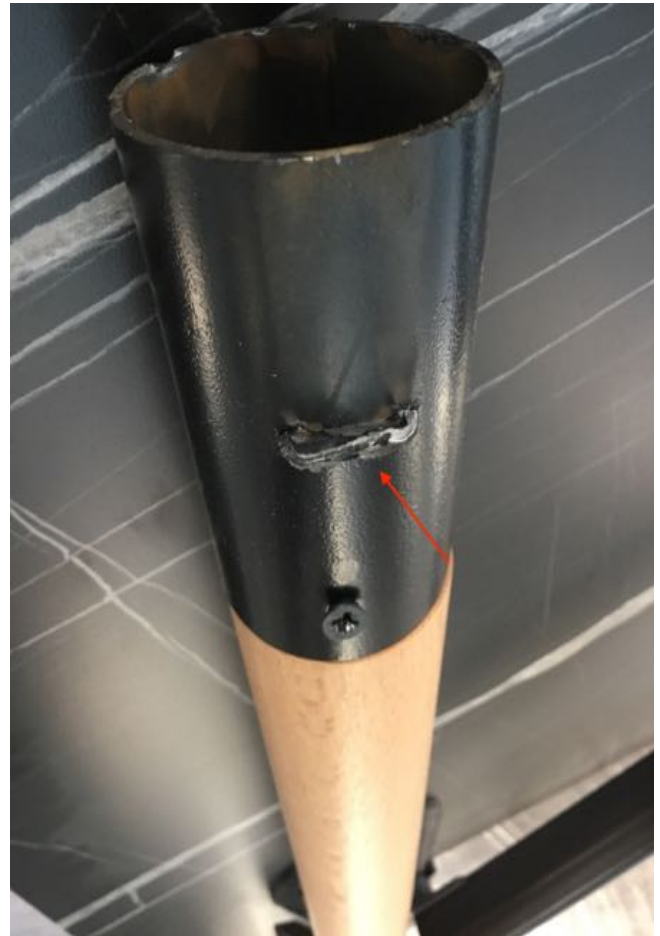
Details of the defects

Direction of the force	Specified horizontal force N	Applied horizontal force N	Number of cycles	Load on top kg	Remarks
Longitudinal (Fa)	300	300	10.100	50	A breakage of the welding between legs and frame has been noticed (see images pag. 2/2)
Longitudinal (Fb)	300	300	10.100	50	
Transverse (Fc)	300	300	10.100	50	
Transverse (Fd)	300	300	10.100	50

The test result does not comply with strength and durability requirements of EN 581-3:2017 clause 5.2.2 (a,b,c)
